THE NAVAL AVIATION SAFETY REVIEW

Aerial Combat

MANEUVERS

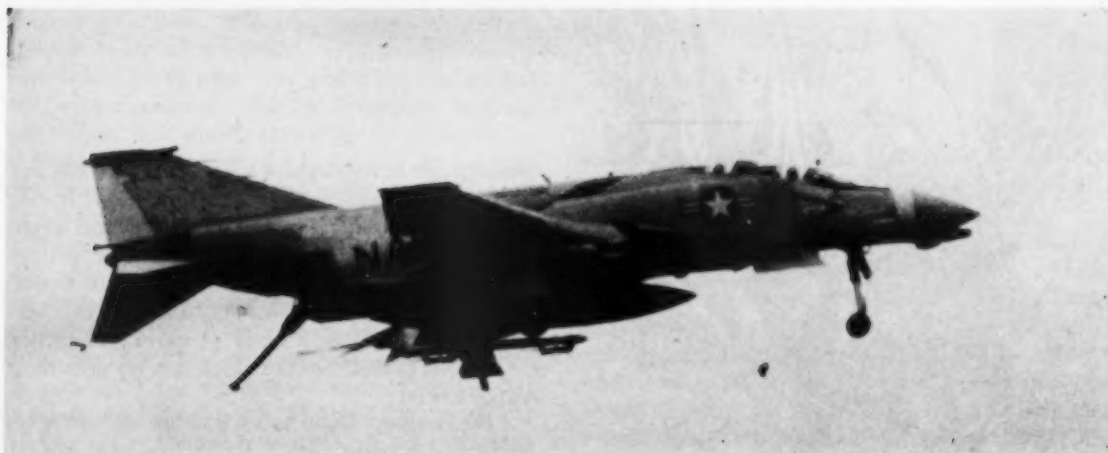
Photo of aircraft taken during fly-by shows port MLG strut.
Note missing wheel.

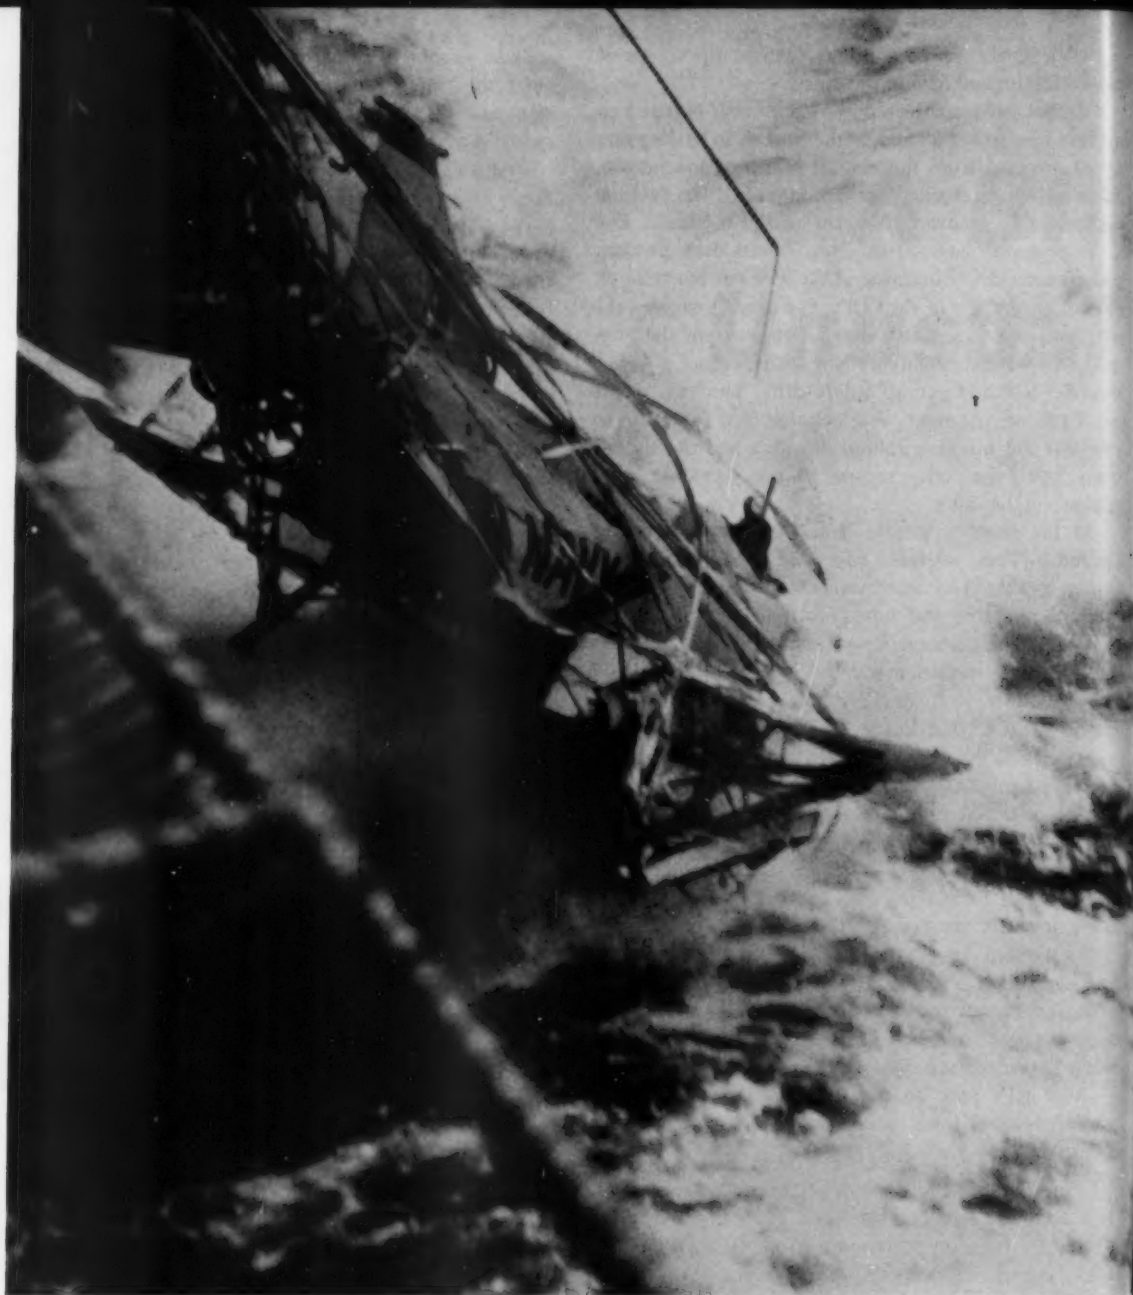
As the aircraft, held by the barricade, hangs from the side of the ship, the RIO prepares to complete his egress.

After extensive study of the failure of the barricade to safely arrest the aircraft, investigators concluded that the barricade itself performed in a satisfactory manner. Had the aircraft remained approximately centered it would have been satisfactorily arrested. The investigators concluded that the engagement of the No. 3 CDP prior to the barricade was the largest contributing factor in causing the aircraft to swerve to the left of centerline and subsequently go over the side. They felt that "the catastrophic results of this arrestment, despite full compliance with published bulletins and the absence of any perceptible personnel factor indicates that the recommended recovery procedures are not adequate under the specific conditions experienced in this accident." In addition to recommending an immediate one-time visual inspection of all AFC 230 Part III main landing gear piston and fork assemblies and a NavAirSysCom investigation of the design adequacy of AFC 230 Part III, the investigators' final report recommended that the aircraft recovery bulletin for F-4B barricade engagements be revised to indicate removal of all wires aft of the barricade when the aircraft configuration is one stub main gear and both other gear down.

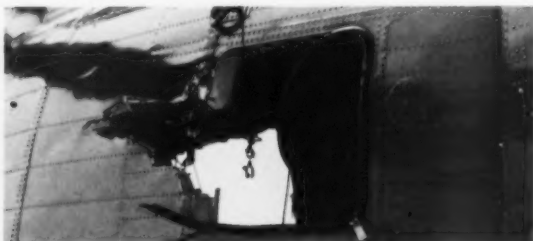
Slight damage.

blades had sheared off about a foot from their tips and the fifth blade was broken in about the same place."

This helo was not lost at sea. It stayed afloat — upright — and was towed safely to the beach by boat. Overhaul restored it to service. It was concluded that the device broached, whipped the cable into the tail rotor causing subsequent oscillations which resulted in the forced landing. The pilot was commended for saving the helo. Such operations are fraught with unknowns and should only be conducted with great care by an experienced crew like this one.

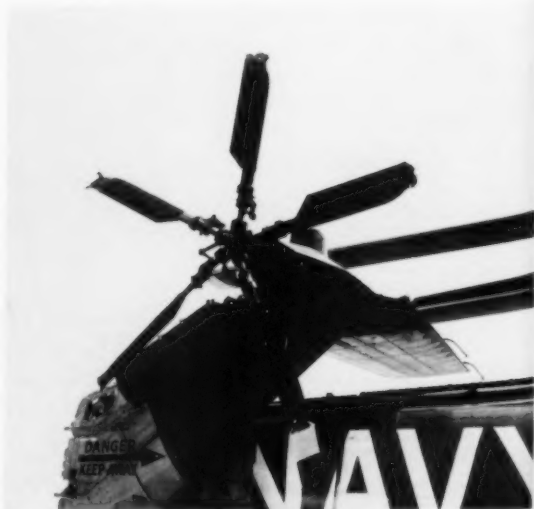
Towline did this.
